**E3633A-05B****S E R V I C E****N O T E**Supersedes:  
E3633A-05A**E3633A DC Power Supply****Serial Numbers: MY51240075 to MY99999999****Metal Strap Kit for tightening loose bumper and for fitting rear lock link in side-by-side rack mounting****Parts Required:**

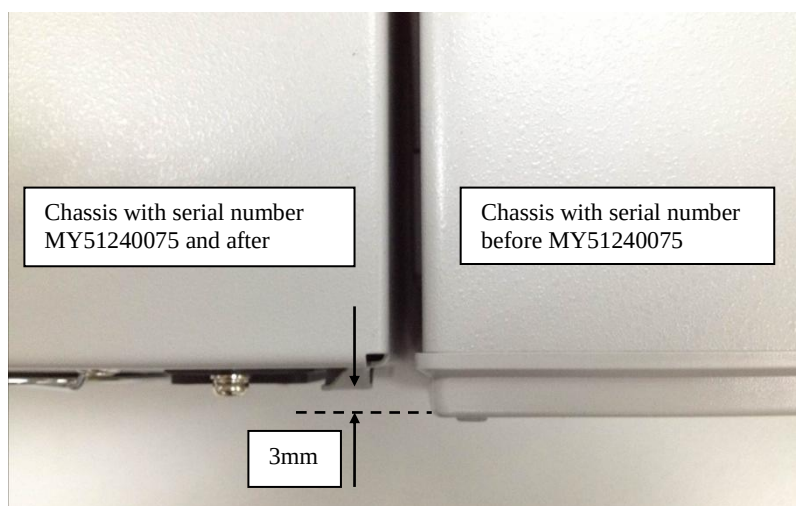
Figure 1: Top view 3mm gap observed between two different chassis designs

The chassis depth difference between the two designs is 3mm as shown in Table 1 and Figure 1 below.

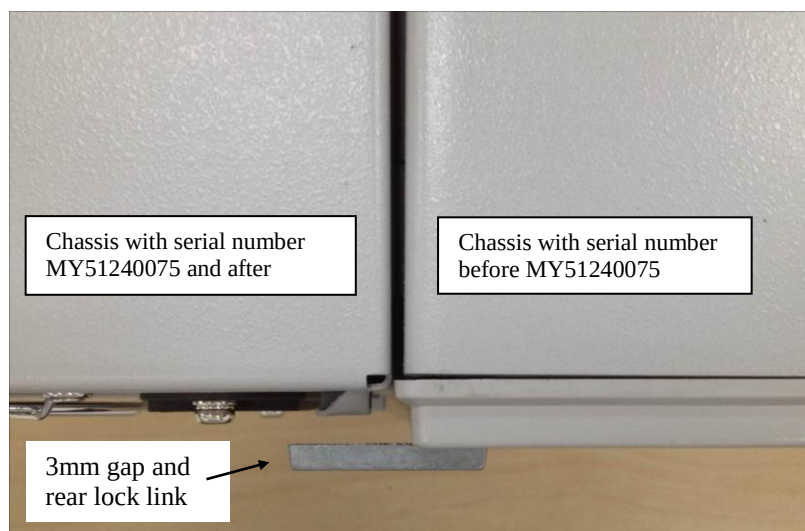
Figure 2: Top view 3mm gap observed on rear lock link for side-by-side rack mounting

The 3 mm gap between the two different chassis may cause difficulties in securing them together using a rear lock link kit (part number 0050-2167) for side-by-side rack mounting as shown in Figure 2 below.

Use metal strap (part number E3631-07901), and stack the provided two metal straps together to form 3mm thickness and secure it with the provided screws on the rear lock link as shown in Figure 4 below.
