**E3634A-05B****S E R V I C E****N O T E**Supersedes:  
E3634A-05A**E3634A DC Power Supply****Serial Numbers: MY51240014 to MY99999999****Metal Strap Kit for tightening loose bumper and for fitting rear lock link in side-by-side rack mounting****Parts Required:**

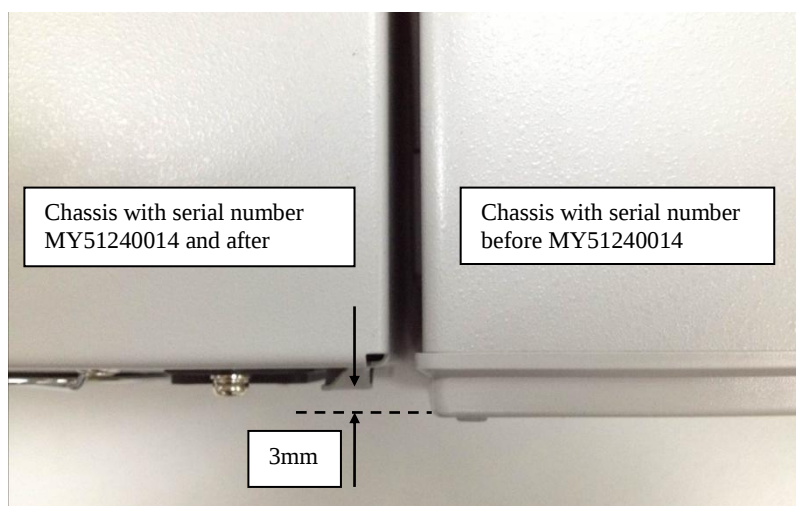
The chassis depth difference between the two designs is 3mm as shown in Table 1 and Figure 1 below.

Figure 1: Top view 3mm gap observed between two different chassis designs

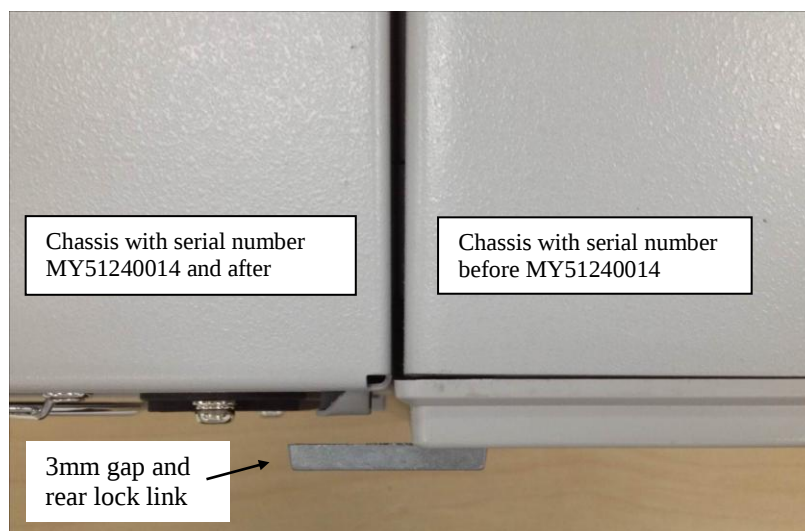
The 3 mm gap between the two different chassis may cause difficulties in securing them together using a rear lock link kit (part number 0050-2167) for side-by-side rack mounting as shown in Figure 2 below.

Figure 2: Top view 3mm gap observed on rear lock link for side-by-side rack mounting

Use metal strap (part number E3631-07901), and stack the provided two metal straps together to form 3mm thickness and secure it with the provided screws on the rear lock link as shown in Figure 4 below.
