**E3643A-02**

**S E R V I C E N O T E**

**E3643A DC Power Supply**

**Serial Numbers: MY40001327 / MY40001520**

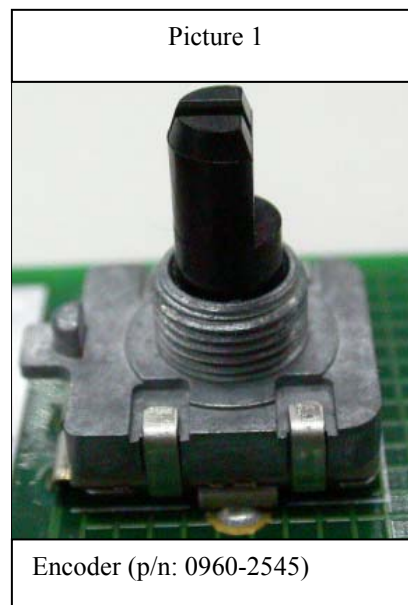
**Difficulty to adjust the knob control on front panel due to encoder issue.**

- 1) When turning the knob of the power supply, user will find it difficult to adjust to get the desired setting (example of difficulty – user need a few turns to increase just a step of voltage/current).
- 2) Some times, by turning the knob clockwise to increase the voltage and current setting, user will see a decrease in values.

- 1) If the unit is confirmed having the problem described above (after verification steps), continue with Step 2. Otherwise, no further action is required.
- 2) Remove encoder (reference designator – RE1) on the front panel display PCA. Replace with another encoder (refer to Picture 1 below).
