**E3646A-04B****S E R V I C E N O T E**Supersedes:  
E3646A-04A**E3646A DC Power Supply****Serial Numbers: MY51240076 to MY99999999****Metal Strap Kit for tightening loose bumper and for fitting rear lock link in side-by-side rack mounting****Parts Required:**

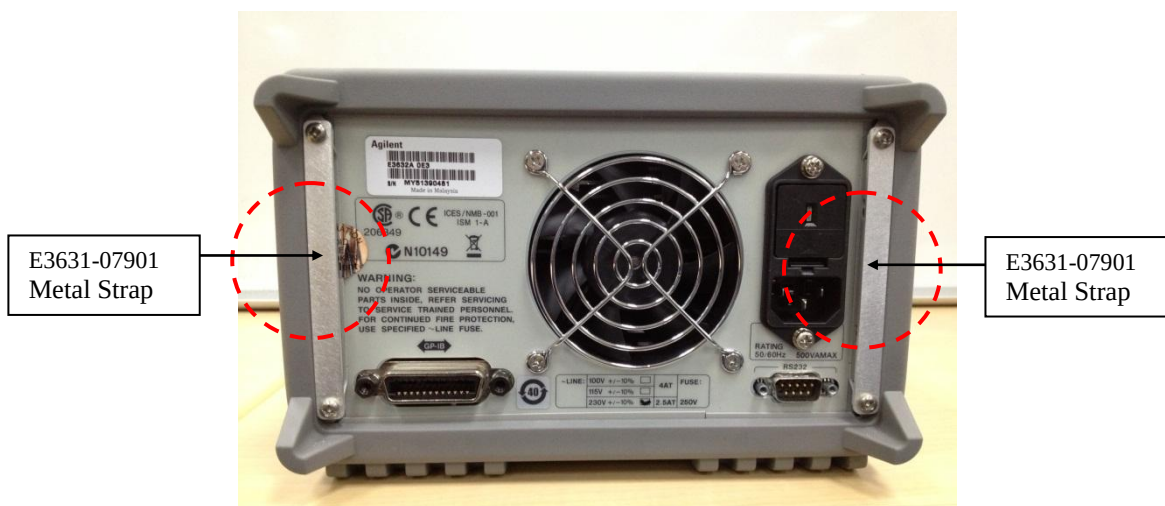
Figure 3: Secure with metal straps – no gap observed between the bumper and chassis

Use two metal straps (part number E3631-07901) to secure each side of the bumper as shown in Figure 3 below.

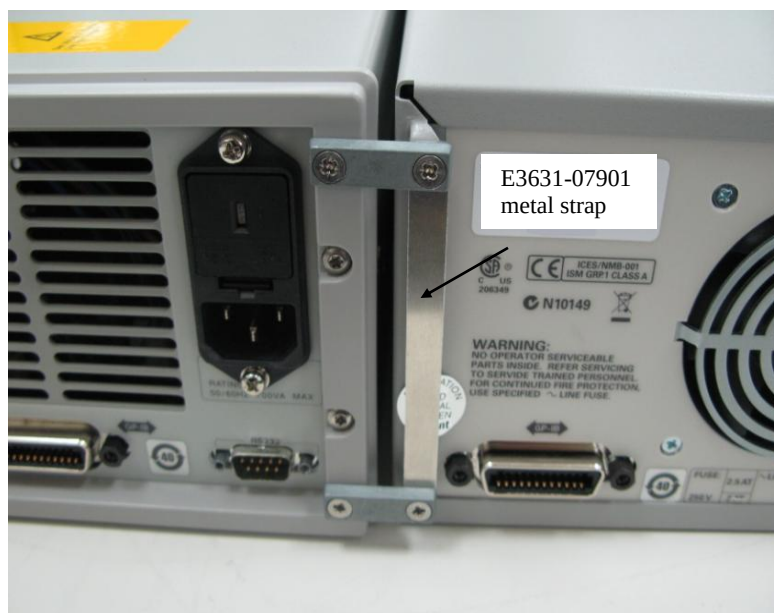
Figure 4: Rear view rear lock link secured with metal straps kit for side-by-side rack mounting

Use metal strap (part number E3631-07901), and stack the provided two metal straps together to form 3mm thickness and secure it with the provided screws on the rear lock link as shown in Figure 4 below.
