**E3647A-04B****S E R V I C E N O T E**Supersedes:  
E3647A-04A**E3647A DC Power Supply****Serial Numbers: MY51240108 to MY99999999****Metal Strap Kit for tightening loose bumper and for fitting rear lock link in side-by-side rack mounting****Parts Required:**

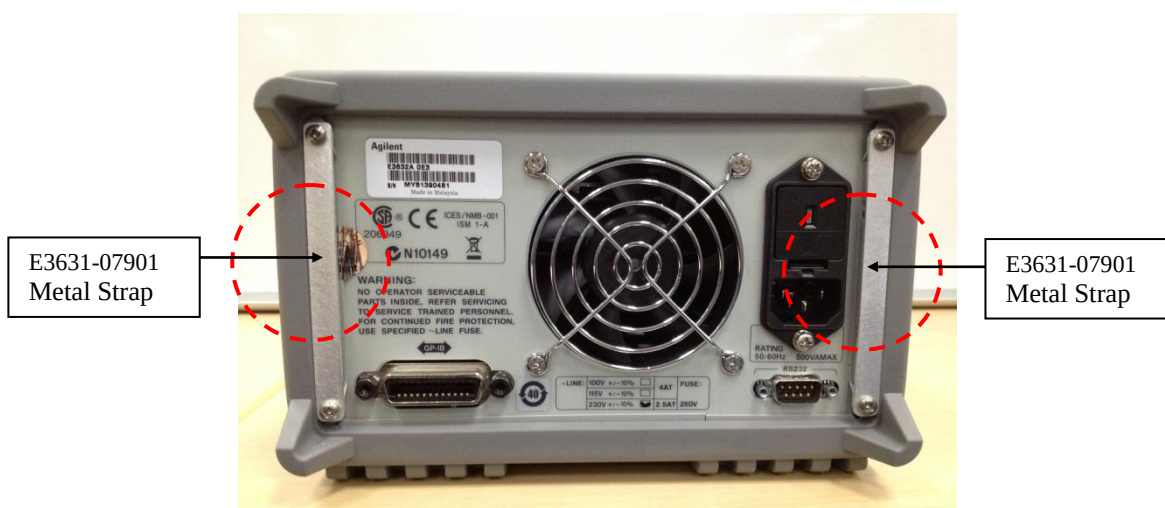
Figure 3: Secure with metal straps – no gap observed between the bumper and chassis

Use two metal straps (part number E3631-07901) to secure each side of the bumper as shown in Figure 3 below.
