**E3649A-04B****S E R V I C E                      N O T E**Supersedes:  
E3649A-04A**E3649A DC Power Supply****Serial Numbers: MY51240078 to MY99999999****Metal Strap Kit for tightening loose bumper and for fitting rear lock link in side-by-side rack mounting****Parts Required:**

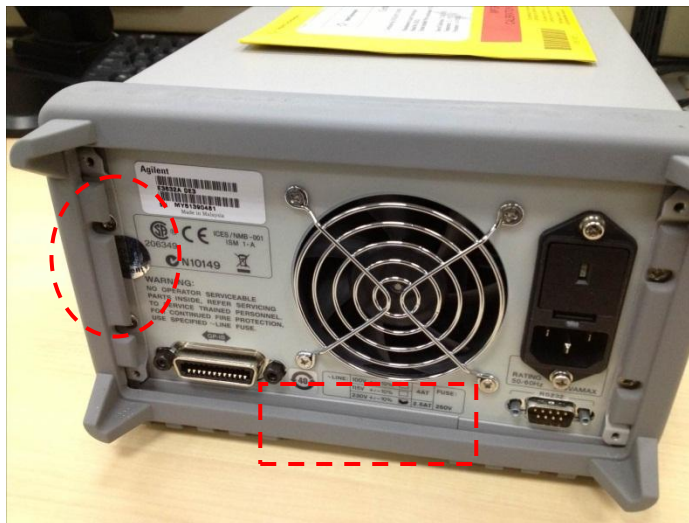
There is a new rear bumper design starting from serial number MY51240078. The rear bumper may become loose or it may slip out of the instrument chassis when force is applied to the rear bumper, as shown in Figure 1 below.

Figure 1: Loose rear bumper – gap observed between bumper and chassis

Use two metal straps (part number E3631-07901) to secure each side of the bumper as shown in Figure 3 below.

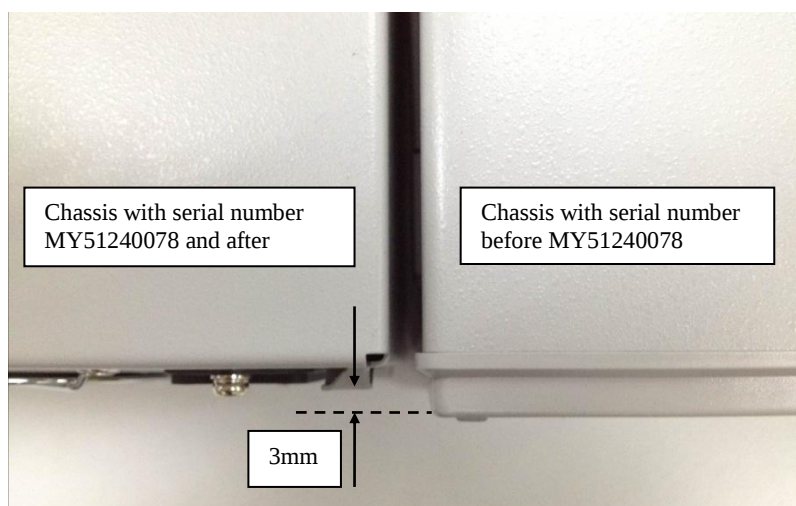
The chassis depth difference between the two designs is 3mm as shown in Table 1 and Figure 1 below.

Figure 1: Top view 3mm gap observed between two different chassis designs

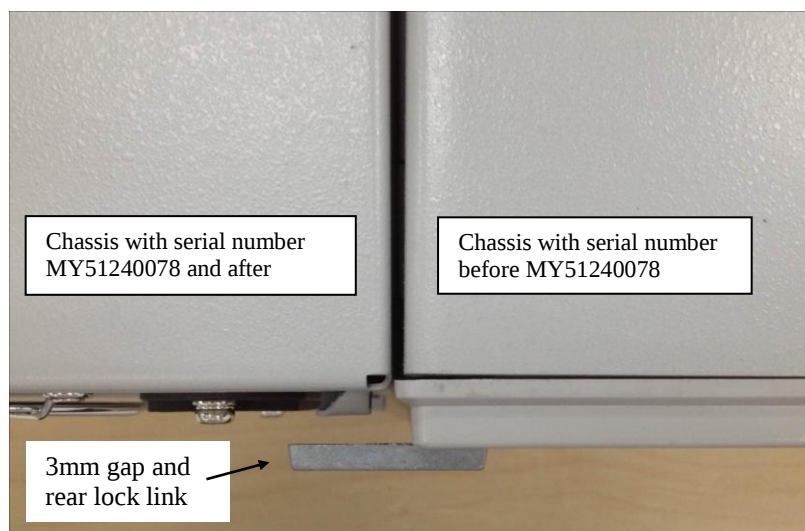
The 3 mm gap between the two different chassis may cause difficulties in securing them together using a rear lock link kit (part number 0050-2167) for side-by-side rack mounting as shown in Figure 2 below.

Figure 2: Top view 3mm gap observed on rear lock link for side-by-side rack mounting

Use metal strap (part number E3631-07901), and stack the provided two metal straps together to form 3mm thickness and secure it with the provided screws on the rear lock link as shown in Figure 4 below.

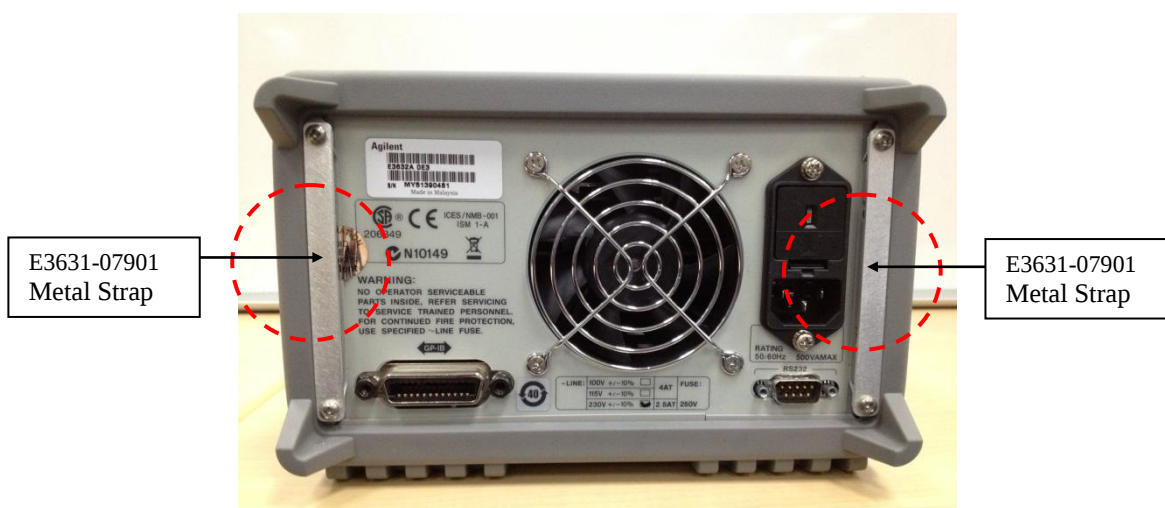
Figure 3: Secure with metal straps – no gap observed between the bumper and chassis

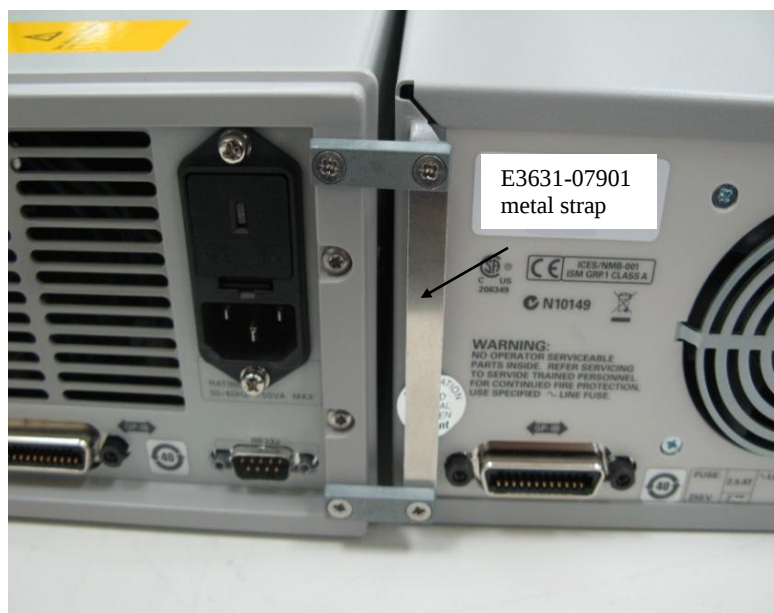
Figure 4: Rear view rear lock link secured with metal straps kit for side-by-side rack mounting
