**E5071C-28****S E R V I C E N O T E**Supersedes:  
NONE**E5071C ENA Series Network Analyzer, 9 kHz to 20 GHz****Serial Numbers: MY46212347 to MY46214506, SG46200264 to SG46200284****Automatically shut down after a few seconds beeping occurs when user turns on the instrument****Parts Required:**

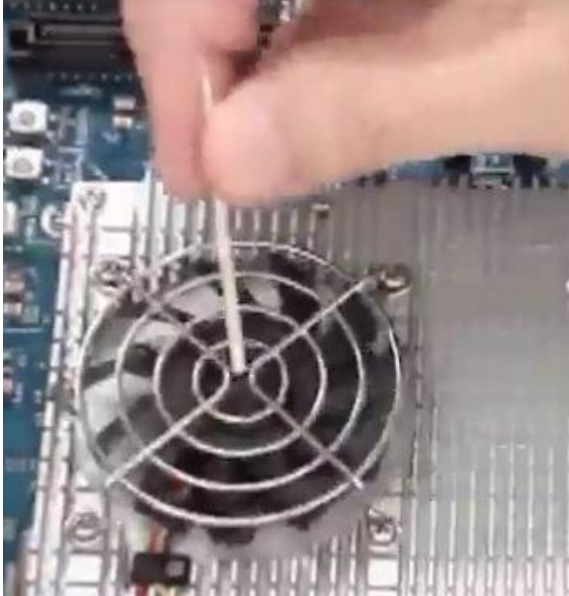
1. Push down CPU fan's rotor using something like tooth pick just after turning on power switch.

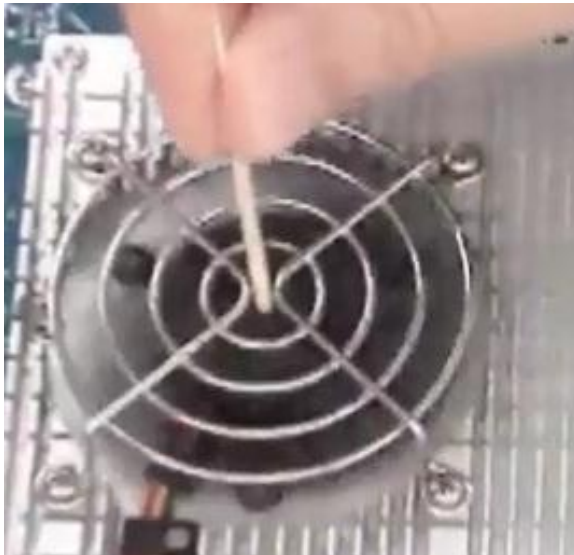
2. If CPU fan rotates, then the cause of the trouble is [dropped off rotor]
