[E6680A-01]

# Modification Recommended Service Note

## E6680A Wireless test set

Serial Numbers: MY60210001 to MY61220112

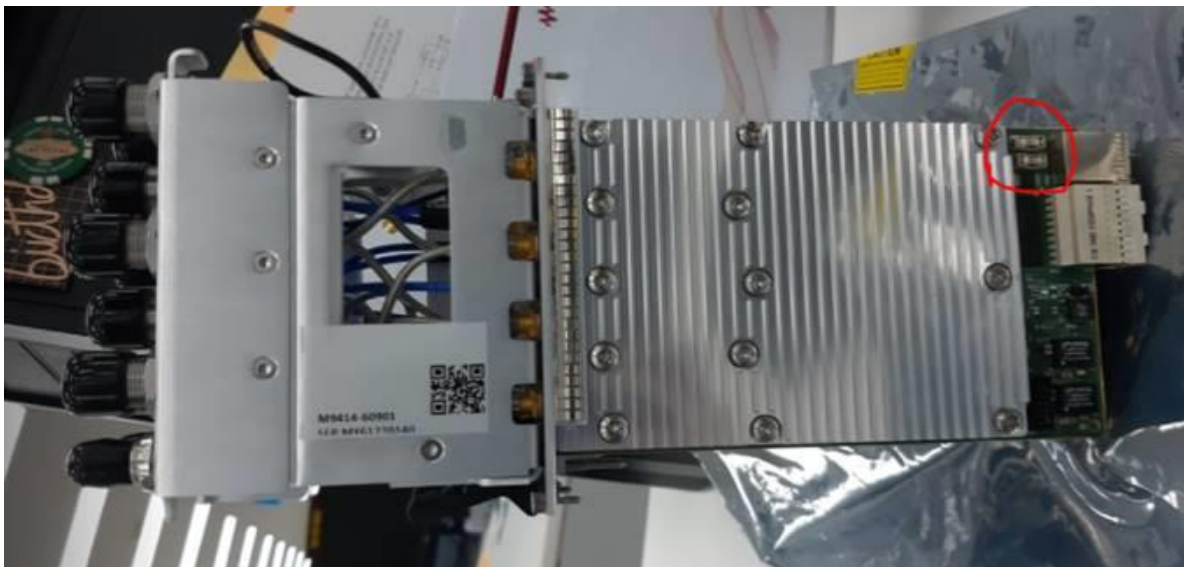
Remove the M9414A module and replace the TWO 5 amp fuses on the right read side of the module with the 7 amp slow blow fuses.

Replaced fast-acting fuse 5A 125V (KPN:2110-1045) with time-delay fuse 7A 125V (KPN: 2110-1787)

Check and Replace F1 and F2 fuses on E6680A instruments with Serial numbers between MY60210001 to MY61220112.
