S E R V I C E N O T E

J2302B Internet Advisor

Serial Numbers: US35340102 / US35340393

Possible fire hazard

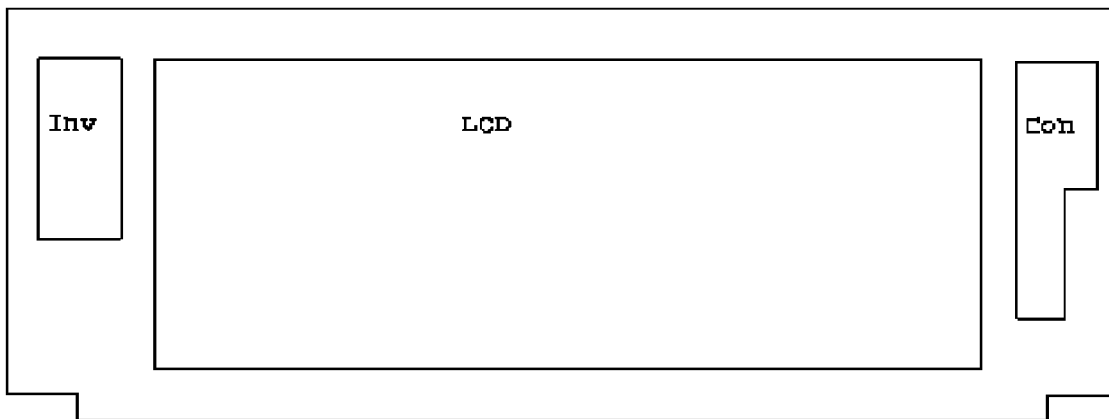
Note Drawing shown with the rear panel removed.

1. Remove the back panel from the display by removing 6 painted screws.
2. Locate 0950-2937 (note drawing marker “Inv”), remove 2 screws and cables from the board and remove the inverter board from the display assembly.
3. Replace the board with 0950-2937 with different LOT number.
