N2832A-01

# Modification Recommended Service Note

## N2832A 13 GHz InfiniiMax III+ Series Probe Amplifier

Serial Numbers: US00000000 / US57270000

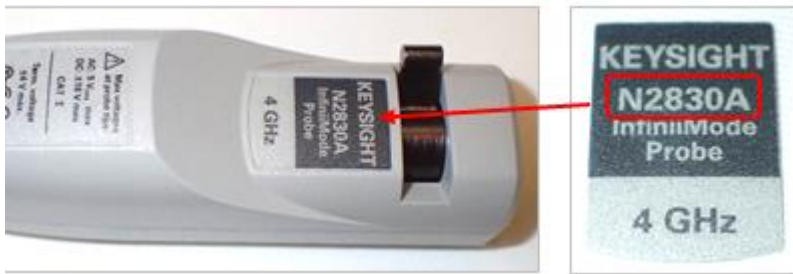
The set screw is underneath the product number label. You must remove the label in order to get to the set screw. Using a wood stick, remove any adhesive residue.

**Be careful NOT to scratch or chip the housing with tweezers.**

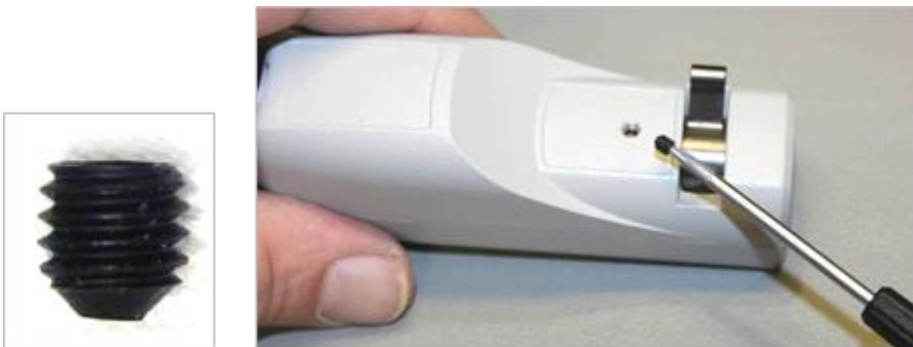
If the set screw is not stainless, it looks like the following after the sticker has been removed:

- a. If the screw is stainless, then remove adhesive and replace the label.
- b. No need to re-calibrate.
- c. If screw is black remove screw using T6 Torx.

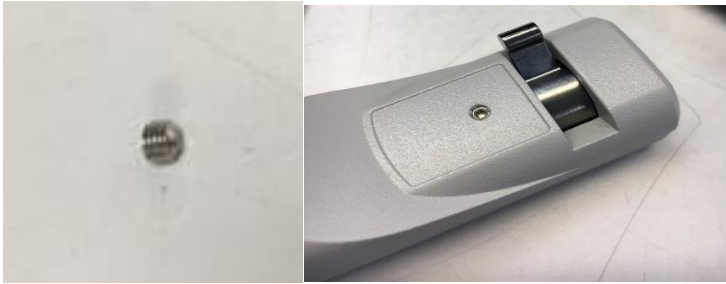
Below is what the new set screw should look like when inside the probe.

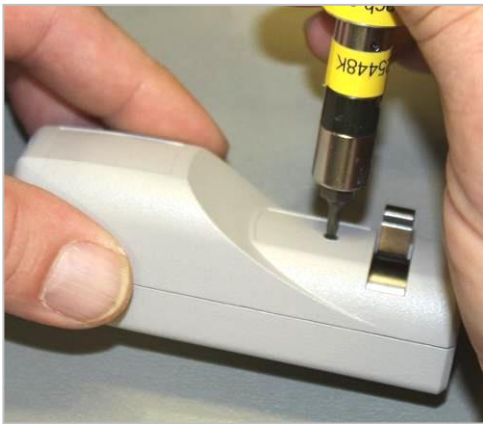
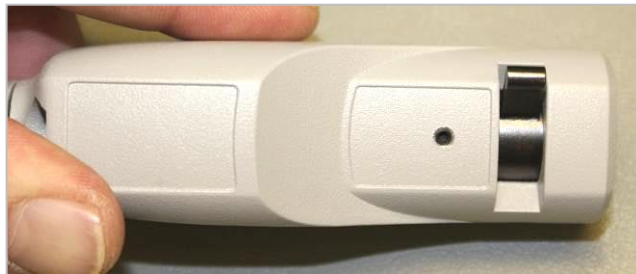
Install screw 0515-5534 Tighten T6 to 18 in oz.

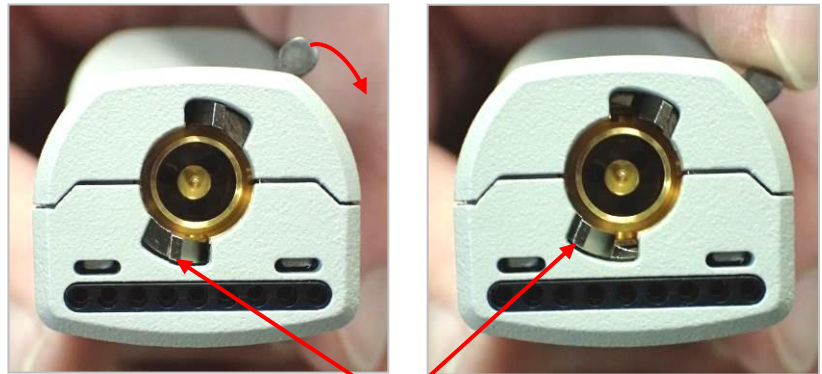
Test the BNC connector by rotating the wing latch **clockwise**, and verify the BNC tab rotates inside the pod housing.

**BNC tab rotates with BNC latch rotation**

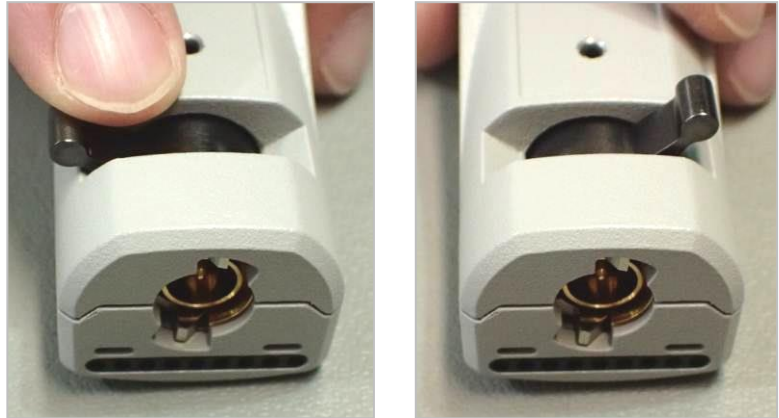
Rotate the BNC wing latch all the way **counterclockwise**. Release the latch to verify the BNC tab rotates back to its original position.

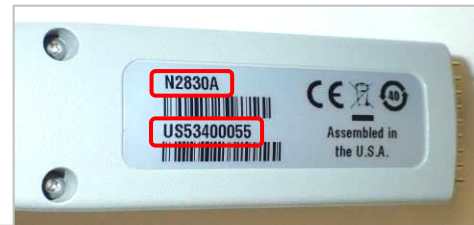
Locate the Pod Product Label (SD107). Verify the **model number** on the Pod product label matches the **model number** printed on the silver Pod SN label in the recessed area of the Pod lower housing.

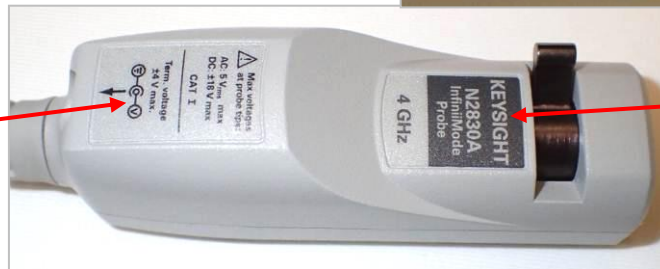
**Pod upper housing with labels**

Align and attach the Pod product label onto the Pod upper housing.

**Secondary  
Pod label**
