N5511A-01

Modification Recommended Service Note

N5511A Phase Noise Test System

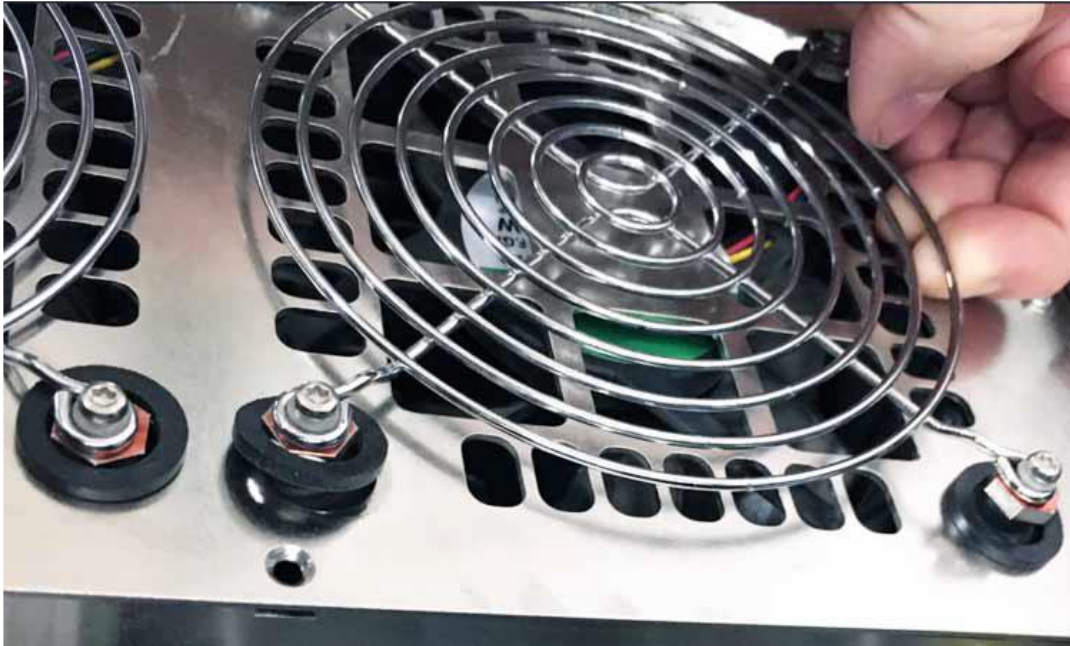
The N5511A fan grommets break down over a 1-to-3-year period and need to be replaced. You can check if they need replacement by visual inspection and pull slightly on the fan protective screen. If they are torn, they need to be replaced.

Use the Fan Grommet replacement kit and this procedure to replace the fan grommets.

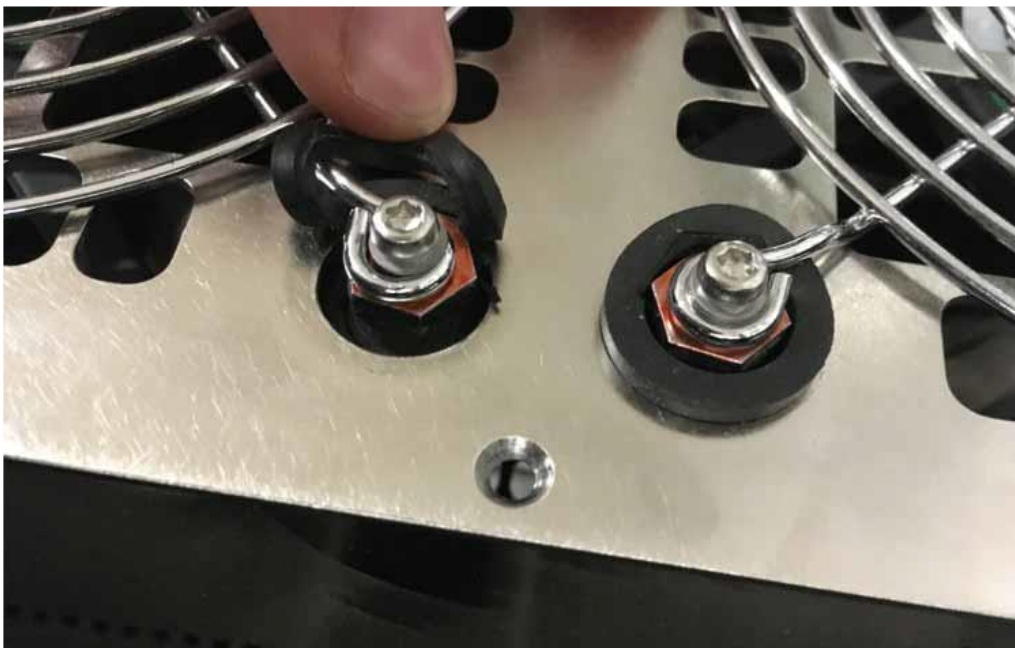
You're looking for rips and tears in the grommet, as shown below:
