N7976A-05

Modification Recommended Service Note

N7976A Advanced Power System – DC Power Supply, 120V, 16.7A, 2000W

The Problem – Front Panel Keypad Incorrect Function Error

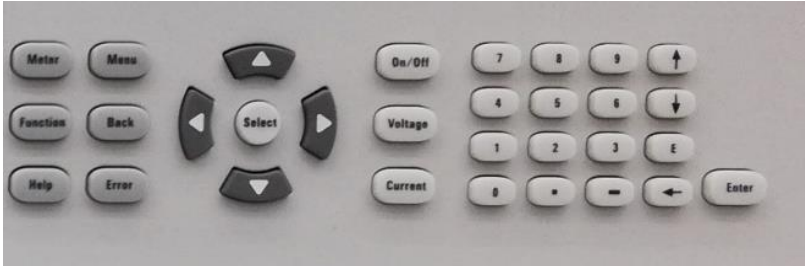
The power supply front panel keypad may respond to incorrect function. Figure below shows the N7976A front panel keypad.

If the described conditions occur, the instrument requires to send back to Keysight service center for front panel PCA board replacement.
