N9914A-07

Modification Recommended Service Note

N9914A FieldFox Handheld RF Analyzer, 6.5 GHz

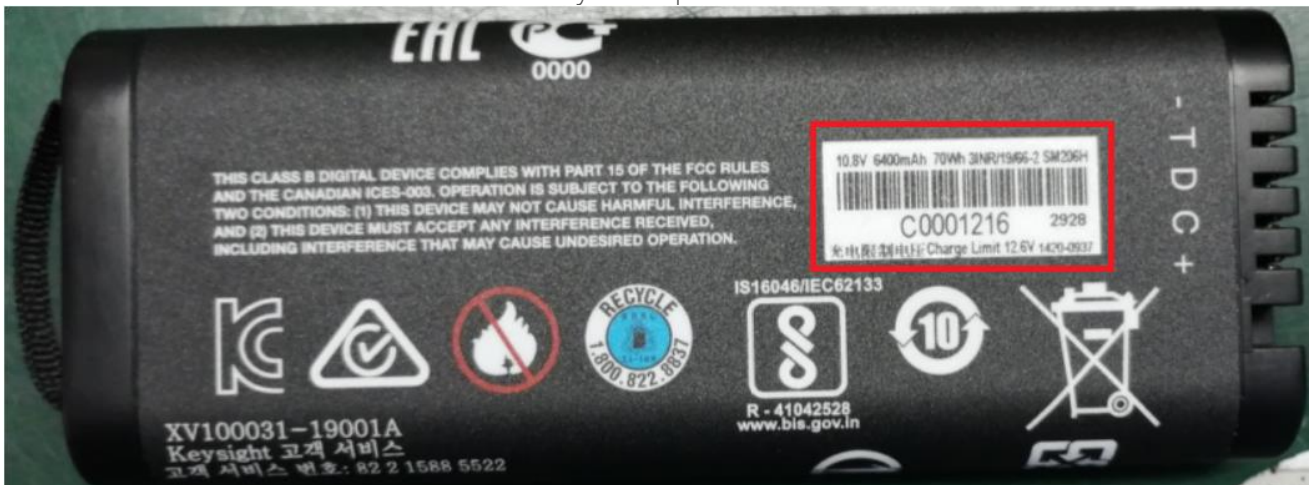
2. Check the serial number of the battery. Refer to the serial number list below.

3. If the battery serial number match the list of serial number below. Please order a new replacement battery (P/N: 1420-0937) from stock. Properly scrap the used battery.
