N9936A-07

Modification Recommended Service Note

N9936A FieldFox Handheld Microwave Spectrum Analyzer, 14 GHz

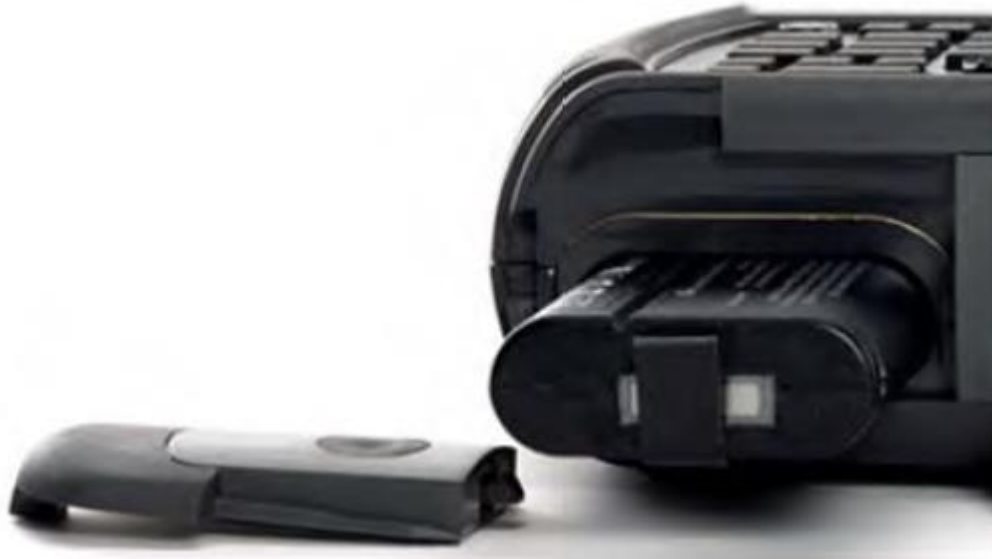
1. Open the battery door and remove the battery from Fieldfox unit.

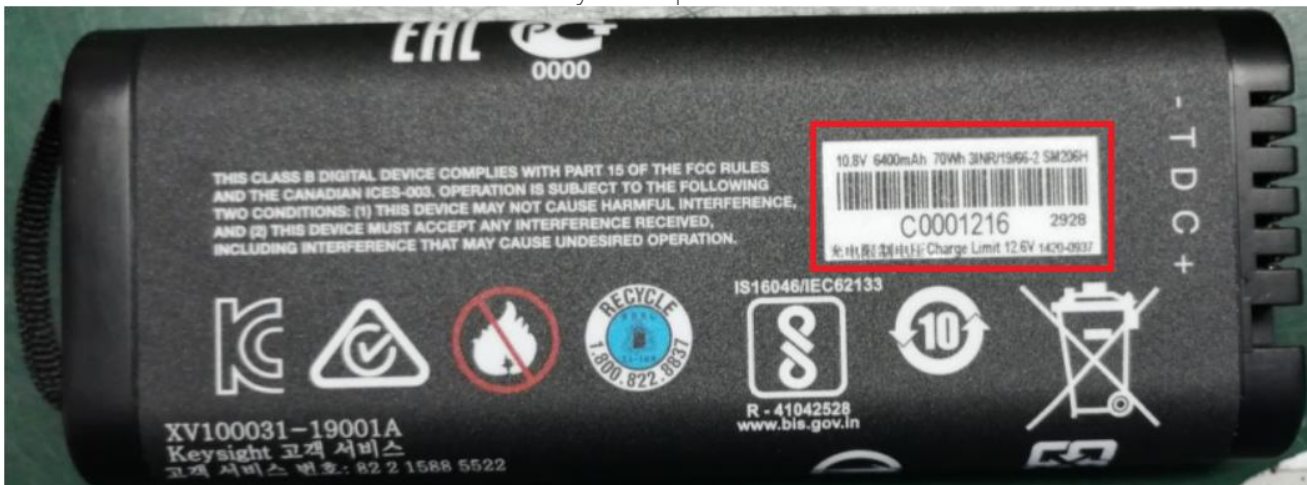
2. Check the serial number of the battery. Refer to the serial number list below.

3. If the battery serial number match the list of serial number below. Please order a new replacement battery (P/N: 1420-0937) from stock. Properly scrap the used battery.
